Subject: Sailplane Rigging – Procedures, Inspections and Training
Ref. Publications:

All sailplanes and powered sailplanes, subject to rigging.

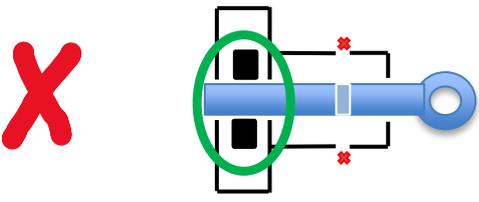
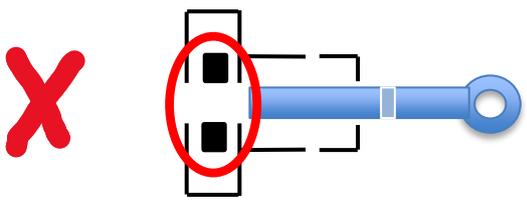
Engaged but <u>not</u> secured.	The bolt moved away from its engaged position, and the control is unconnected.

To engage means e.g. that a bolt is inserted into a bushing. In this condition, the connection is able to transmit forces, but the bolt can move out of the bushing again, therefore the connection is not secure. All connections need to be engaged and secured.

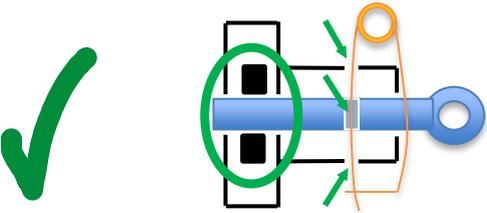
The Fokker-needle needs to be pushed through both holes of the cage and the hole of the bolt.
Engaged and secured.

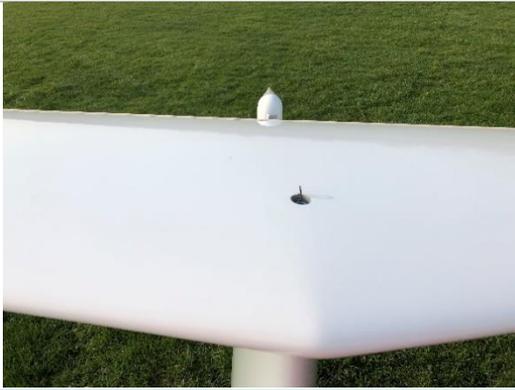
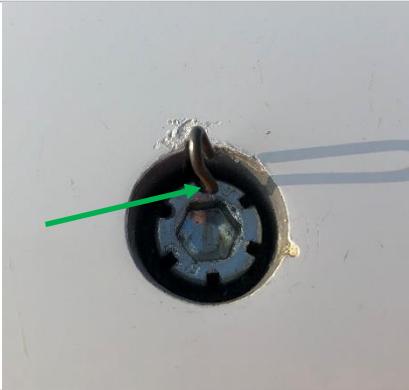
<p>The bolt needs to be engaged and secured against rotation.</p>

Some connections need to be secured against rotation. In most of the cases, this is achieved by the use of a castellated nut and a Fokker-needle. The pin of the needle has to be pushed through two castells and a hole inside the screw.

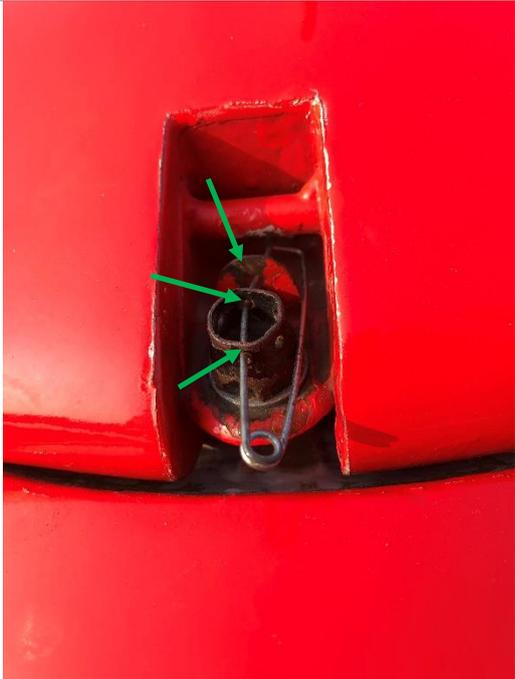
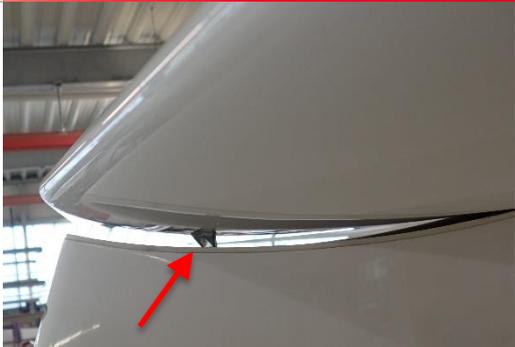
<p>Horizontal stabilizer engaged in its aft fitting but forward fitting not engaged.</p>

Note: All cases of unconnected controls and unconnected horizontal stabilizers can be detected by performing a positive control check. Non-interruption during the rigging helps to prevent forgetting the connections in the first place. The checking of proper securing can be done by a visual inspection only.

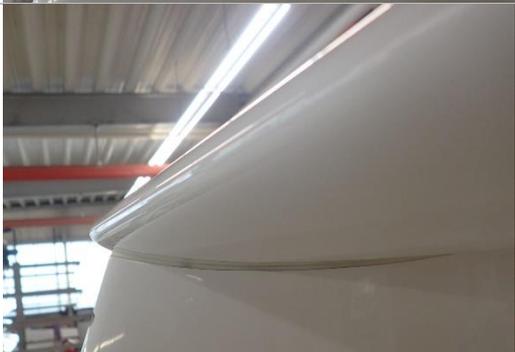
<p>Horizontal stabilizer properly engaged.</p>

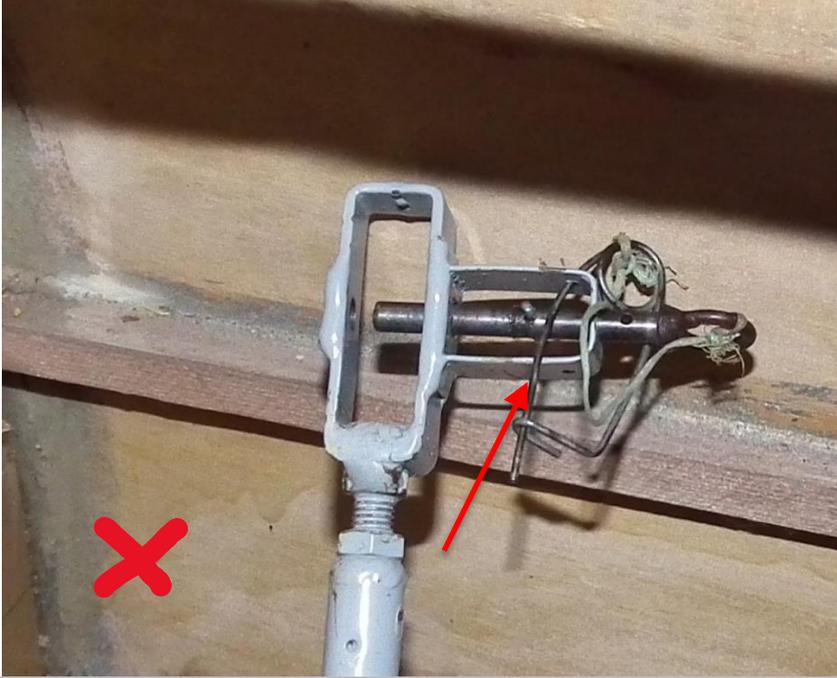
The example below shows an aileron connection, which is typical for old sailplanes with manual control connections. In this case, the connection was engaged during rigging, but not correctly secured. After three flights of short duration, the bolt moved away from its engaged position. The pilot lost control and crashed fatally.

<p>The connection was not secured. The Fokker-needle was put through one hole of the cage only, but not through the bolt and the lower hole of the cage, as well. By this, the bolt could move freely and the control connection could become unconnected.</p>

Note: Connections, which are not properly secured, cannot be detected by positive control checks. The proper securing can be verified only by a manual inspection through turning, pulling, or shaking of the bolt and further visual inspection.

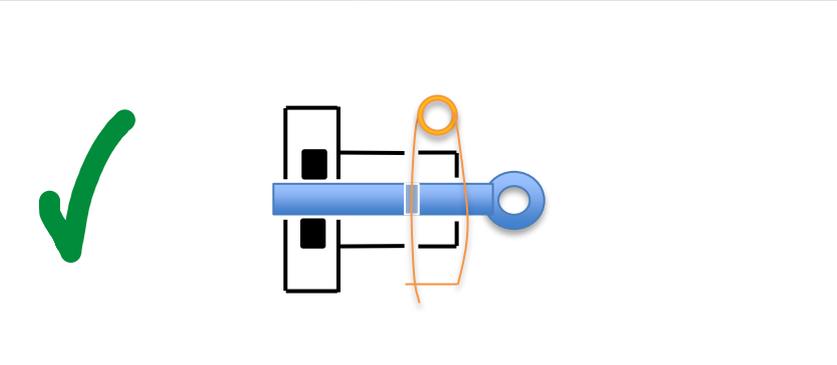
<p>The bolt is secured by pushing the Fokker-needle through <u>all three</u> holes.</p>

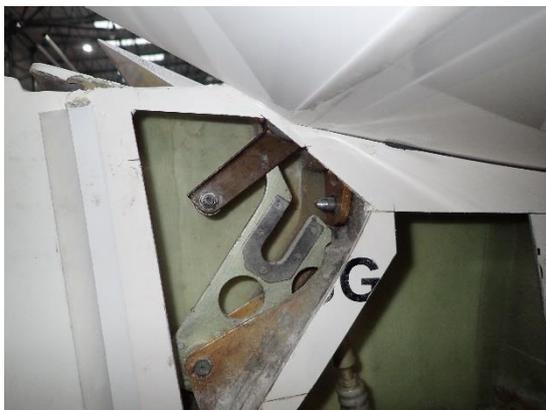
Similar designs can be found for the control connection of the elevator. Pictures below show an example of a mis-rigged vertical stabilizer, which led to a fatal accident. The mis-rigging had its root cause in an unauthorized and apparently unrecorded modification, to make rigging easier.

Disconnected elevator control

Note: Those examples of rigging errors can usually be detected by a proper positive control check as indicated above.

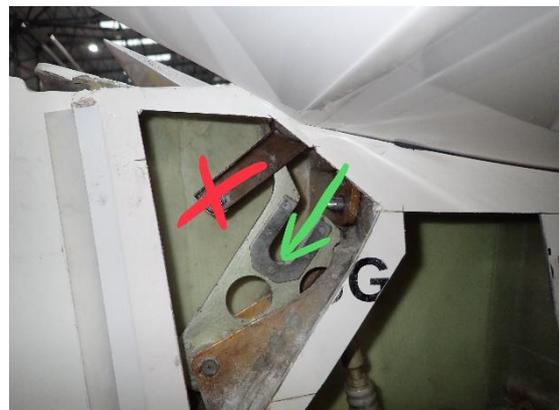
Disconnected elevator control

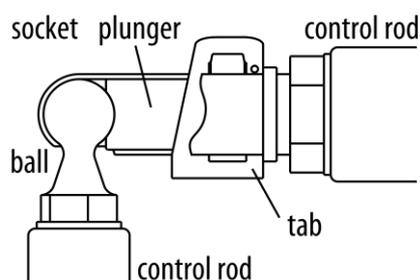
(a) Correct: cut-away shows how tab holds plunger in place

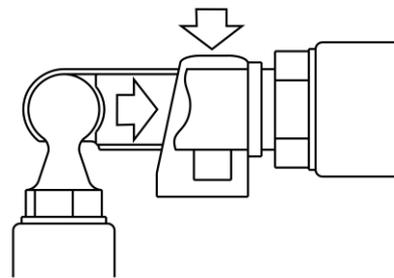
(b) Open: with tab depressed, plunger allows ball to be inserted or removed

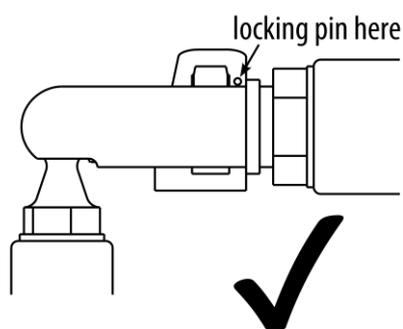
(c) Correct: ball engaged, locking pin may be inserted

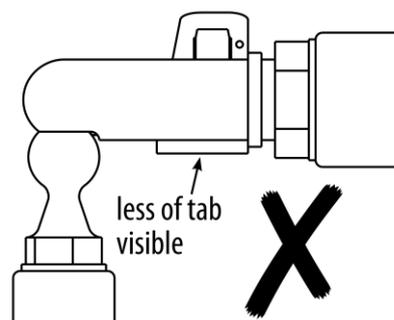
Unfortunately, the tab adopts a similar position when the ball and socket are completely disconnected and, although the ball is then locked out of the socket, it may in some cases engage sufficiently for the controls to seem connected. Being able to insert the locking pin does not guarantee that the connection has been properly made.

(d) Incorrect: ball not engaged, but locking pin may still be inserted

It is crucial to check that the ball and socket are correctly engaged. This can be difficult, if access is tight or illumination poor; a torch and mirror, or telephone camera, can help.

Note: To check the proper engagement of l'Hotellier connectors, a positive control check is strongly recommended.

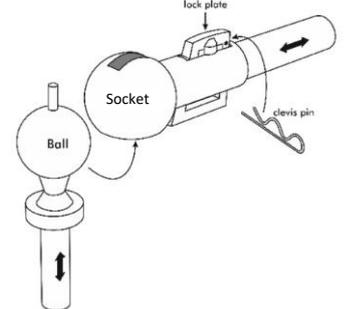
<p>Newer l'Hotellier connectors come with a pin on the top of the ball that becomes visible outside the socket, once the ball and socket are properly engaged. The pin allows also for a tactile inspection. The connection still needs to be secured.</p>

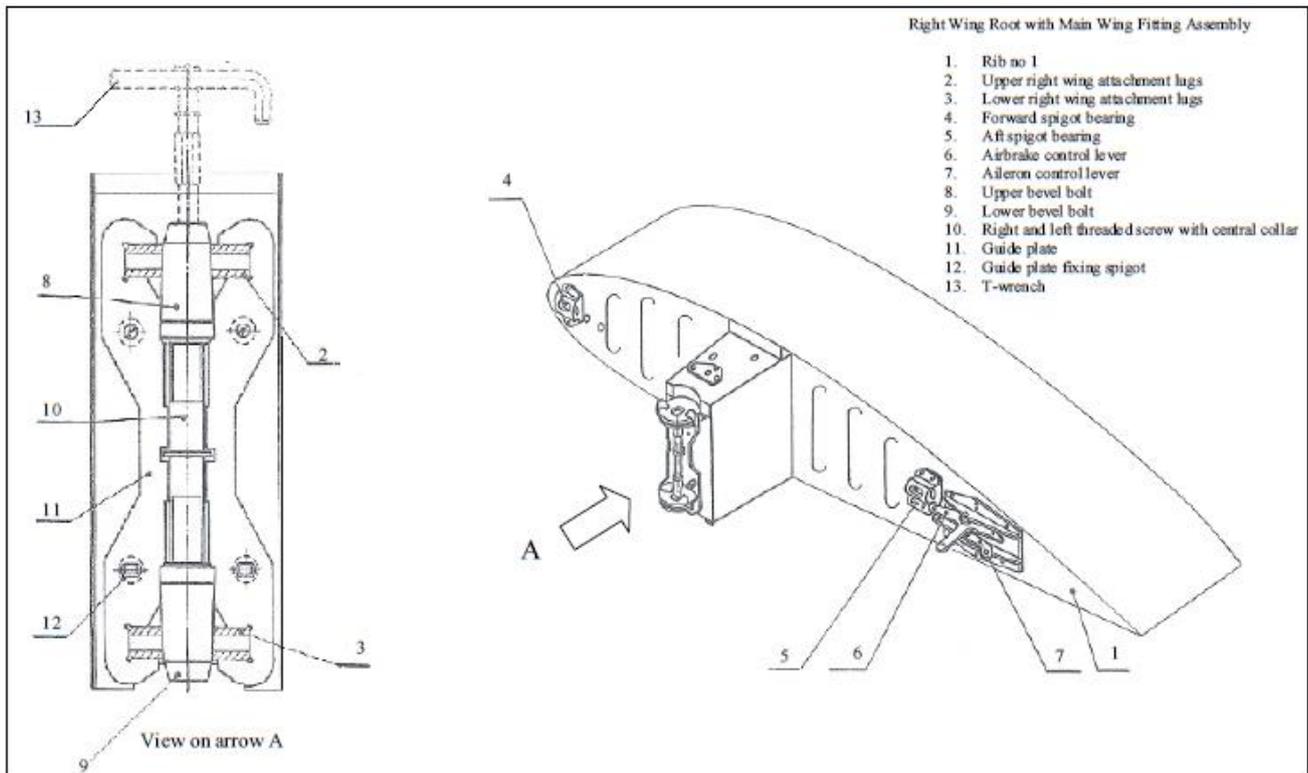
The wing rigging pins for most gliders are smooth cylinders, but those for e.g. the Foka, Cobra, Bocian, Jaskółka, Schempp-Hirth SHK and Austria, consist of expanding pins/cones, which must be fitted exactly in accordance with the instructions of the flight manual. If the pin/cone is not correctly located, the wings can fold up and detach from the fuselage. Unless inspection holes have been cut for the purpose, it can be very difficult in some gliders to see whether the fitting has been assembled correctly.

Example of an expanding main pin wing connection.

Note: In case of sailplanes with expanding main pin wing connections, practice rigging should be carried out under the supervision of someone who is familiar with the sailplane type.
